The Atlas of Hillforts of Britain and Ireland Hillfort survey (v2 October 2013)

2.1. Name of the site:	Guilsborough
2.2. Alternative name of the site:	None
2.3 National Grid Reference:	467460 272900
2.4. Any known reference numbers:	NMR No. SP 67 SE 3; Mon. No. 341910 HER report refs: 6772010 and 22/93
2.5. Current county/Unitary authority:	Northamptonshire, Daventry District
2.6. When did you visit the site (month/year):	20 June 2015

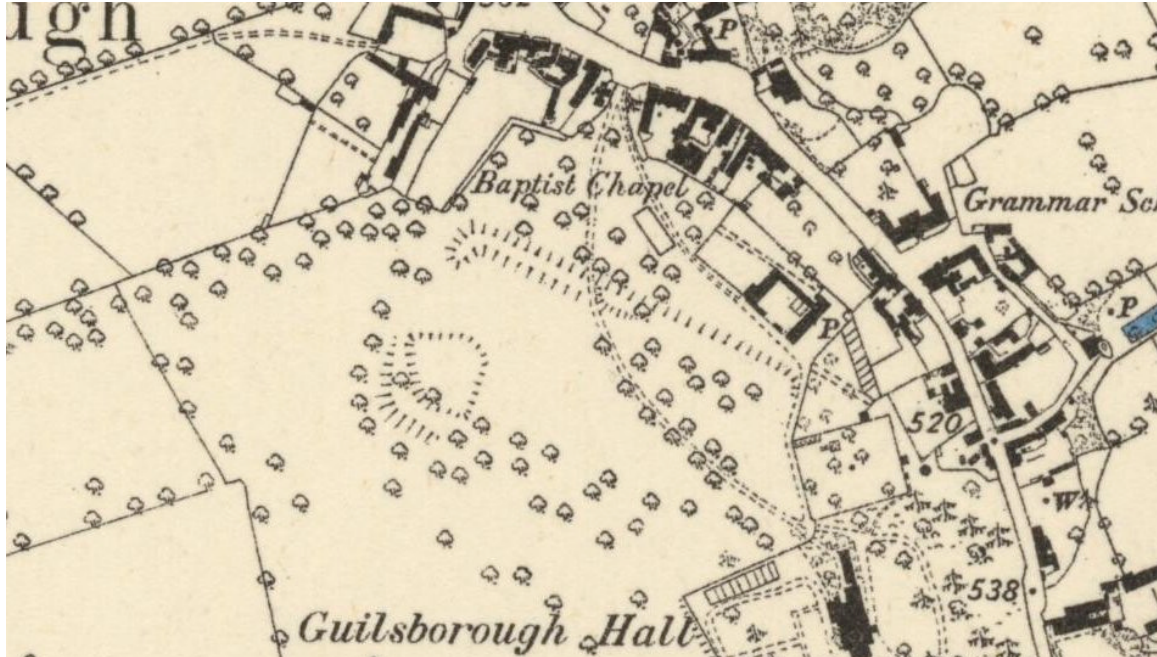
The above extract from the 1884 OS 6" map gives a good indication of the probable original shape and size of the hillfort enclosure.

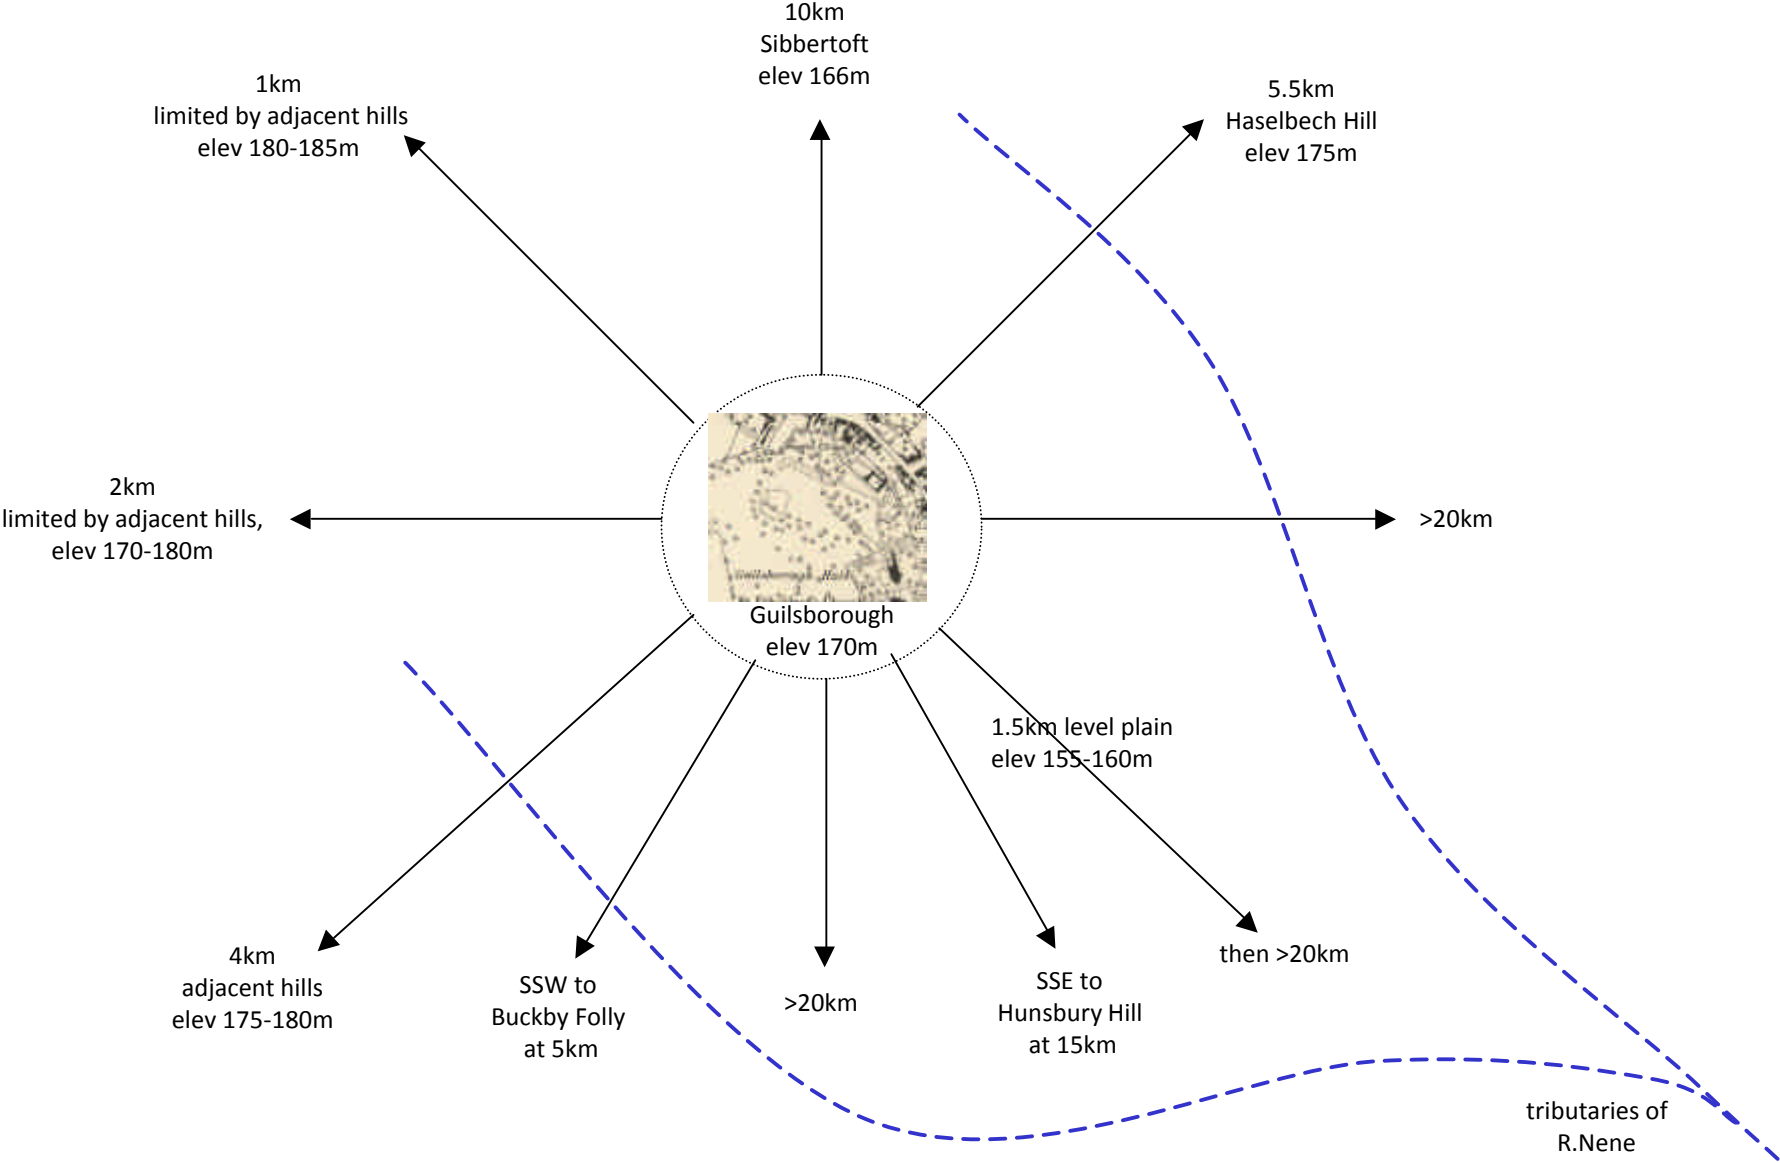
Viewshed diagram for Guilsborough

The viewshed diagram for this site is shown overleaf. Note the very extensive views to the south and east, and the easy visibility between the Iron Age sites at Guilsborough and Hunsbury Hill (Northampton).

MEDIUM	X (app. 3.5 Kms. but obstructed by modern buildings)
SHORT	.
Comments:	The viewshed diagram (in the Appendices) shows extensive views to N, E & S (however these are now obstructed by modern housing and tree growth). To the west, visibility is limited at about 2-4km by an adjacent line of hills at 170-180m OD.
